DRIGGS MUNICIPAL AIRPORT (TETON PEAKS)

This report describes how your pavement maintenance management program was developed. This program was developed as part of the Network Pavement Management Program project sponsored by the Idaho Transportation Department, Division of Aeronautics. The information and data contained in this report ensures you are in compliance with the requirements of Federal Aviation Administration (FAA) Grant Assurance Number 11 which states that any airport requesting federal funds for pavement improvement projects must have implemented a pavement maintenance management program (PMMP).

Using the branch, section and sample unit divisions established, a visual condition survey was conducted at Driggs Municipal Airport (Teton Peaks) on November 01, 2006. During the inspection pavement defects were identified and measured in accordance with the methodology outlined in FAA AC:150/5380-6 and ASTM D5430. Our inspection ensures your airport complies with the “detailed inspection” requirement of FAA’s PMMP guidelines. After collection, the data were entered into the Micro PAVER software for analysis. These data are reproduced in the Re-Inspection Report attached in

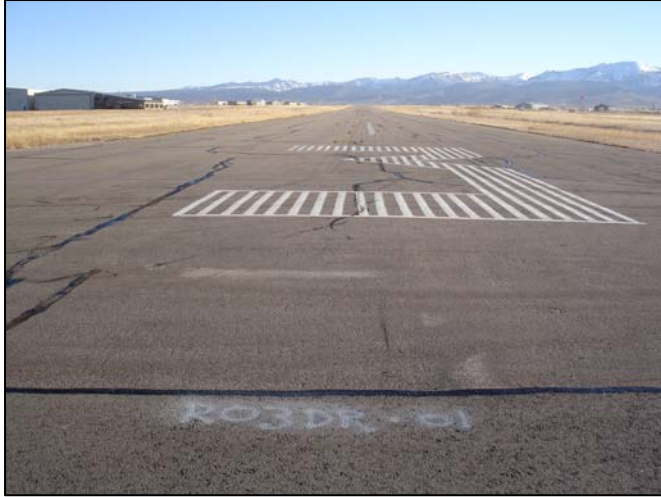
Sample Number: 01 Type: R Area: 5,625.00SqFt PCI = 76
48 LONGITUDINAL/TRANSVERSE CRACKING L 400.10 Ft
48 LONGITUDINAL/TRANSVERSE CRACKING M 32.01 Ft

Section: R03DR-01
Longitudinal/ Transverse Cracking

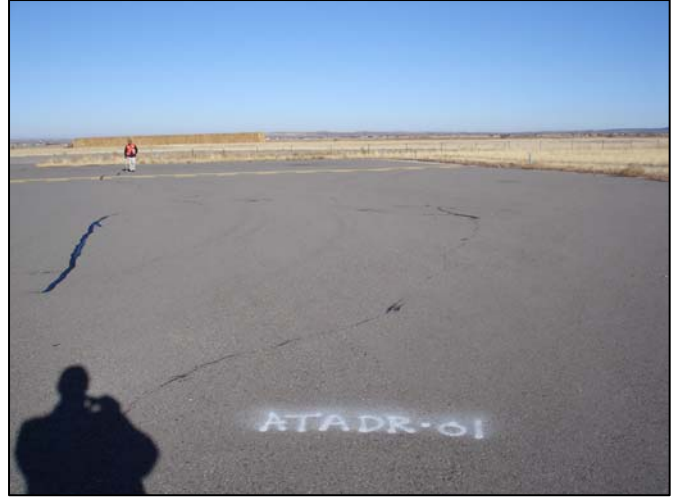
Sample Number:	01	Type:	R	Area:	5,587.00SqFt	PCI = 96
48	LONGITUDINAL/TRANSVERSE	CRACKING	L	34.01	Ft	
Sample Number:	02	Type:	R	Area:	5,625.00SqFt	PCI = 74
48	LONGITUDINAL/TRANSVERSE	CRACKING	L	34.01	Ft	
52	WEATHERING/RAVELING	H	85.00	SqFt

Section: ATADR-01
Longitudinal/ Transverse Cracking
Weathering/ Raveling

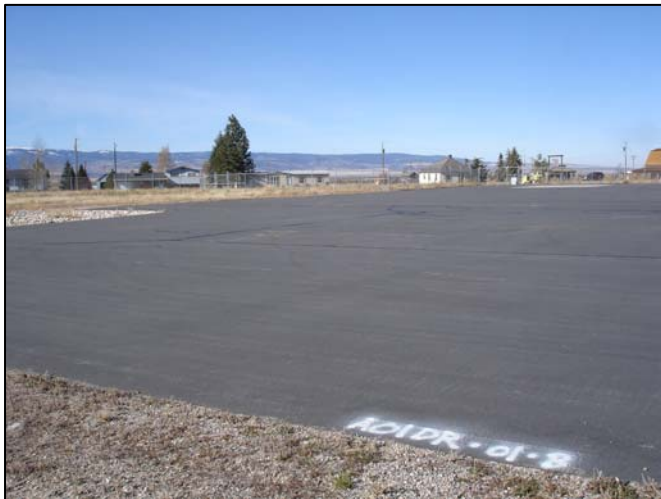
Sample Number:	01	Type:	R	Area:	5,000.00SqFt	PCI = 90
48	LONGITUDINAL/TRANSVERSE	CRACKING	L	140.04	Ft	
Sample Number:	02	Type:	R	Area:	5,000.00SqFt	PCI = 87
48	LONGITUDINAL/TRANSVERSE	CRACKING	L	210.05	Ft	
Sample Number:	03	Type:	R	Area:	4,550.00SqFt	PCI = 88
48	LONGITUDINAL/TRANSVERSE	CRACKING	L	170.04	Ft

Section: A01DR-01
Longitudinal/ Transverse Cracking

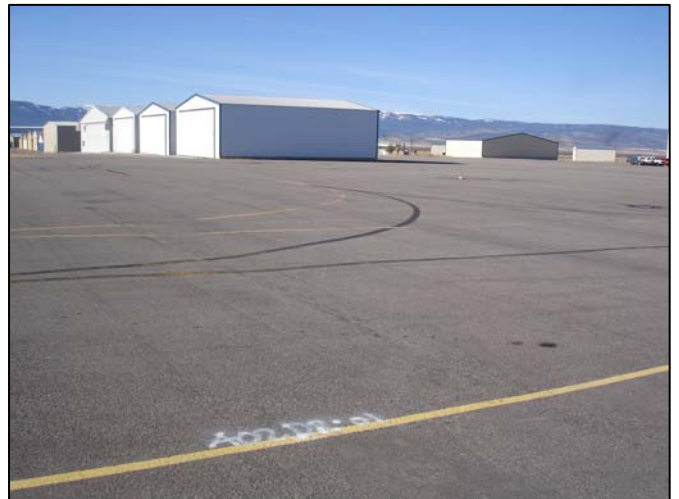
Sample Number: 01 Type: R Area: 5,000.00SqFt PCI = 95
48 LONGITUDINAL/TRANSVERSE CRACKING L 44.01 Ft

Section: A02DR-01
Longitudinal/ Transverse Cracking

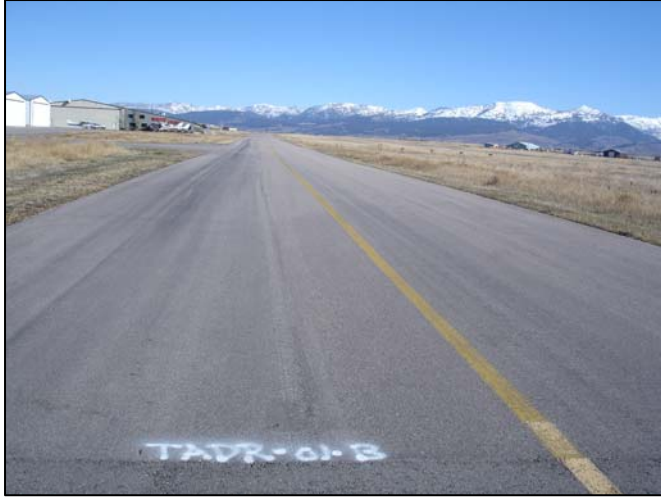
Section: TADR-01
No Distress

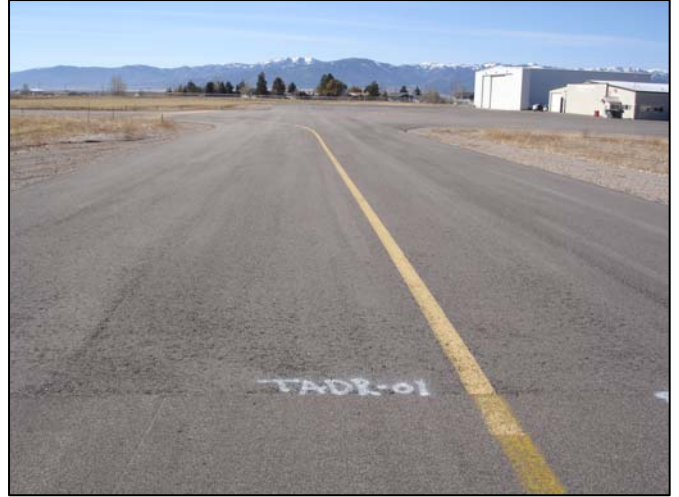
Sample Number: 04 Type: R Area: 5,250.00SqFt PCI = 89
48 LONGITUDINAL/TRANSVERSE CRACKING L 57.01 Ft
48 LONGITUDINAL/TRANSVERSE CRACKING M 15.00 Ft

Section: TADR-02
Longitudinal/ Transverse Cracking

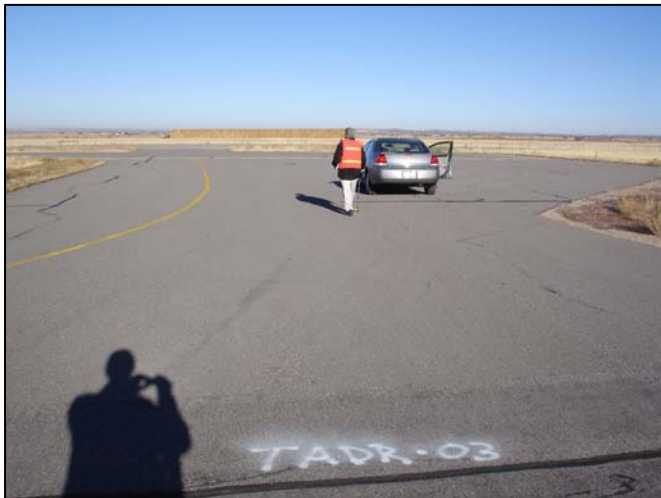
Section: TADR-03
Longitudinal/ Transverse Cracking

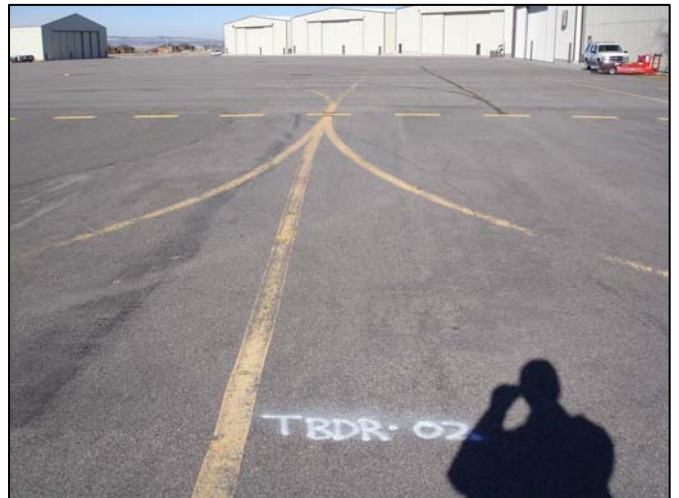
Section: TBDR-02
Weathering/ Raveling
Longitudinal/ Transverse Cracking

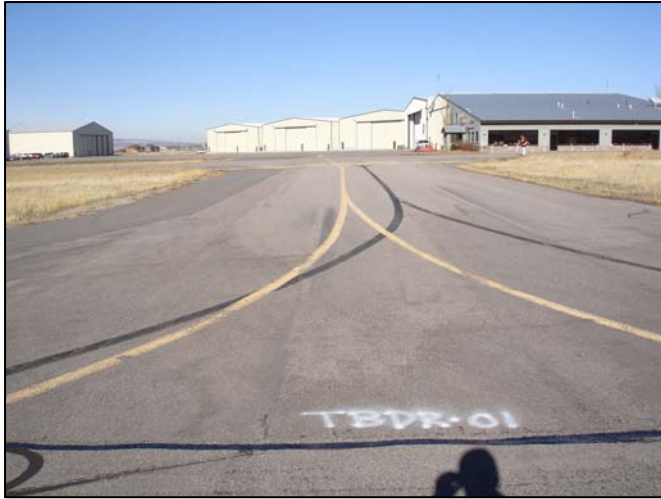
Section: TBDR-01
Weathering/ Raveling
Longitudinal/ Transverse Cracking

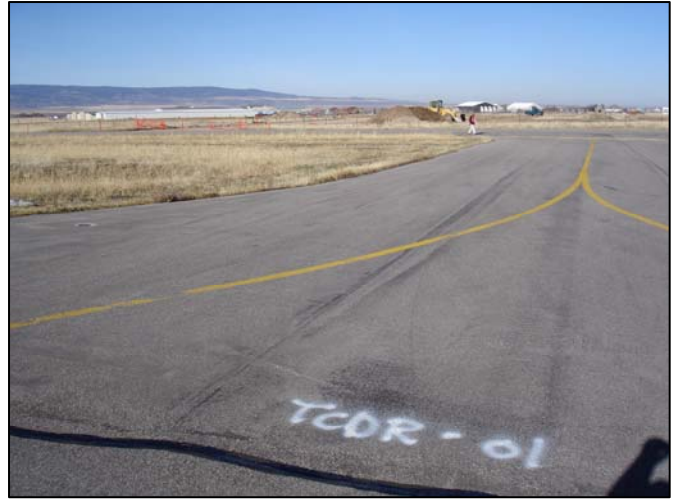
Section: TCDR-01
Weathering/ Raveling
Longitudinal/ Transverse Cracking

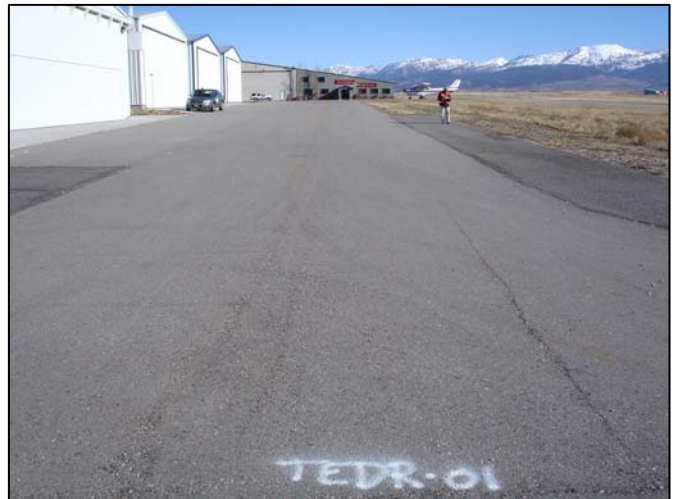
Section: TEDR-01
Weathering/ Raveling

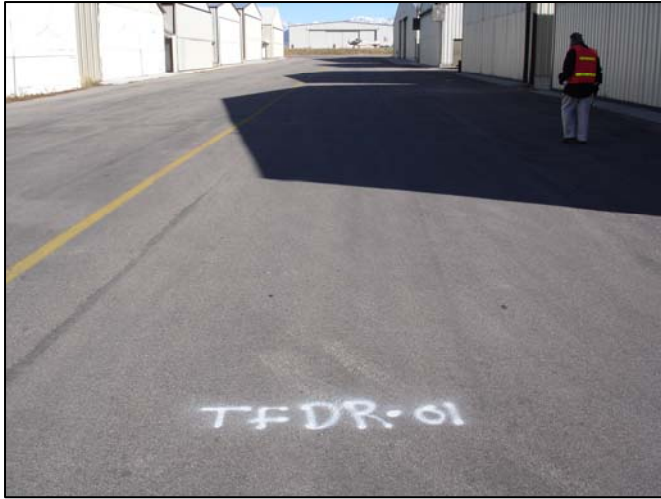
Sample Number:	01	Type:	R	Area:	5,630.00SqFt	PCI = 70
48	LONGITUDINAL/TRANSVERSE	CRACKING	L	461.12	Ft	
48	LONGITUDINAL/TRANSVERSE	CRACKING	M	10.00	Ft	
50	PATCHING		L	164.00	SqFt	
Sample Number:	04	Type:	R	Area:	5,025.00SqFt	PCI = 91
48	LONGITUDINAL/TRANSVERSE	CRACKING	L	123.03	Ft	
Sample Number:	06	Type:	R	Area:	5,025.00SqFt	PCI = 94
48	LONGITUDINAL/TRANSVERSE	CRACKING	L	63.02	Ft	
Sample Number:	07	Type:	R	Area:	5,025.00SqFt	PCI = 93
48	LONGITUDINAL/TRANSVERSE	CRACKING	L	99.03	Ft

Section: TFDR-01
Longitudinal/ Transverse Cracking

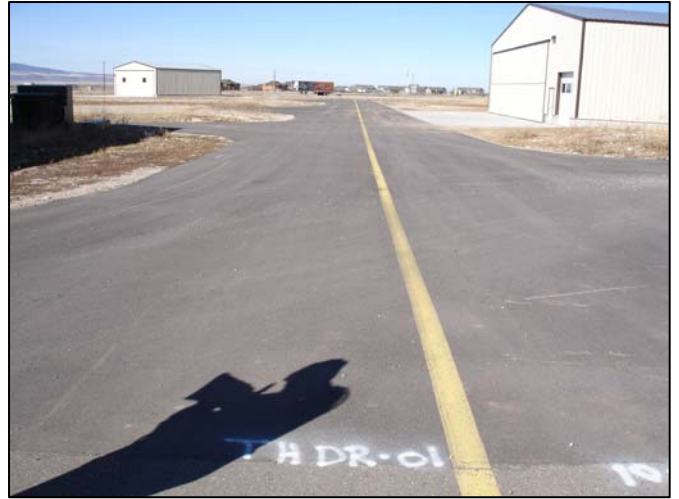
Sample Number:	01	Type:	R	Area:	2,540.00SqFt	PCI = 79
52	WEATHERING/RAVELING			L	1,349.99 SqFt

Section: THDR-01
Weathering/ Raveling

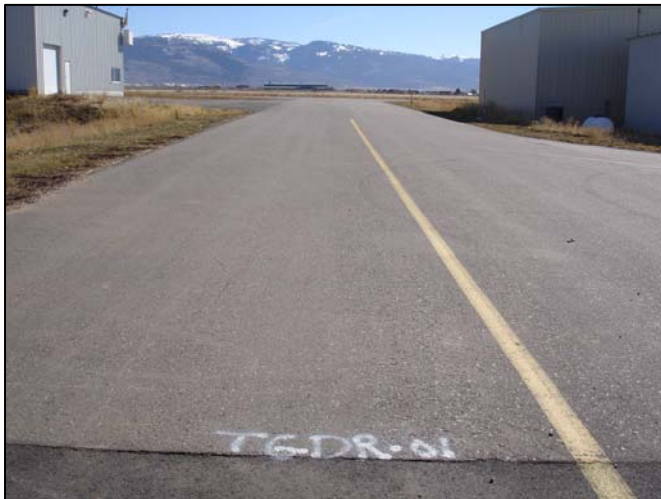
Section: TGDR-01
No Distress

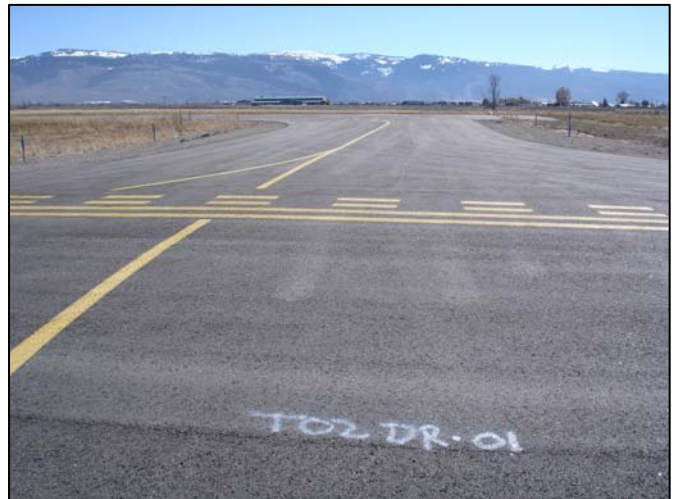
Network:	DRIGGS	Name: DRIGGS MUNICIPAL AIRPORT (TETON PEAKS)							
Branch:	T02DR	Name: Taxiway 02 Driggs				Use: TAXIWAY	Area:	7,403.00SqFt	
Section:	01	of	1	From: Runway 3 End		To: Apron 01		Last Const.: 8/5/2004	
Surface:	AC	Family: Idaho AC Taxiways			Zone: U02	Category: 5	Rank: P		
Area:	7,403.00SqFt	Length: 152.50Ft		Width: 35.00Ft					
Shoulder:	Street Type:		Grade: 0.00	Lanes: 0					
Section Comments:									
Last Insp. Date		11/1/2006		Total Samples: 1		Surveyed: 1			
Conditions: PCI:100.00									
Sample Number: 01		Type: R		Area: 7,403.00SqFt		PCI = 100			
<NO DISTRESSES>

Section: T02DR-01
No Distress
